The Road Inventory of Harris Neck National Wildlife Refuge Townsend, GA

Prepared By:
Federal Highway Administration
Central Federal Lands Highway Division
November, 2011

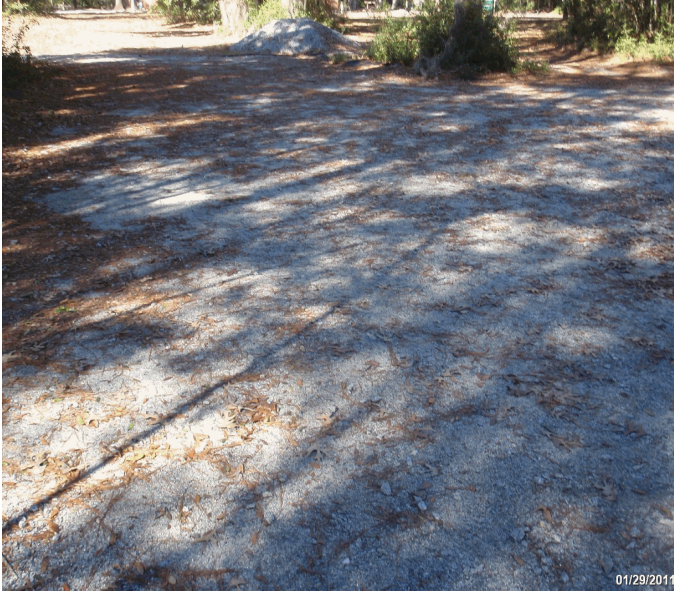
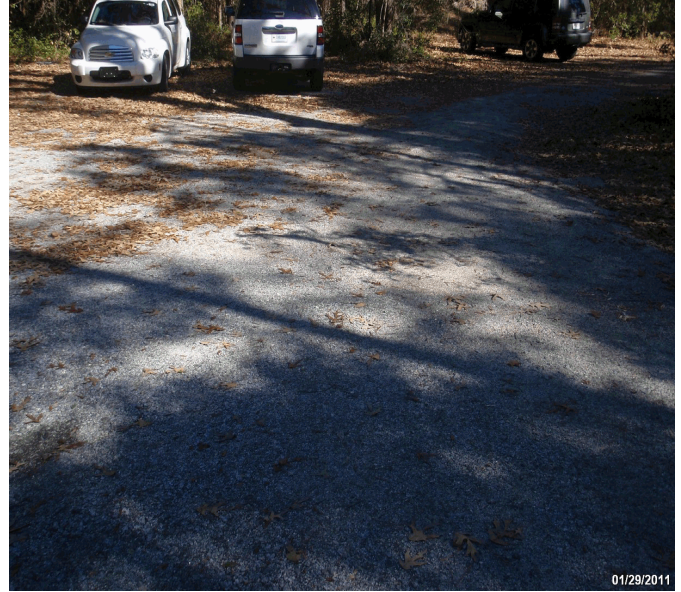
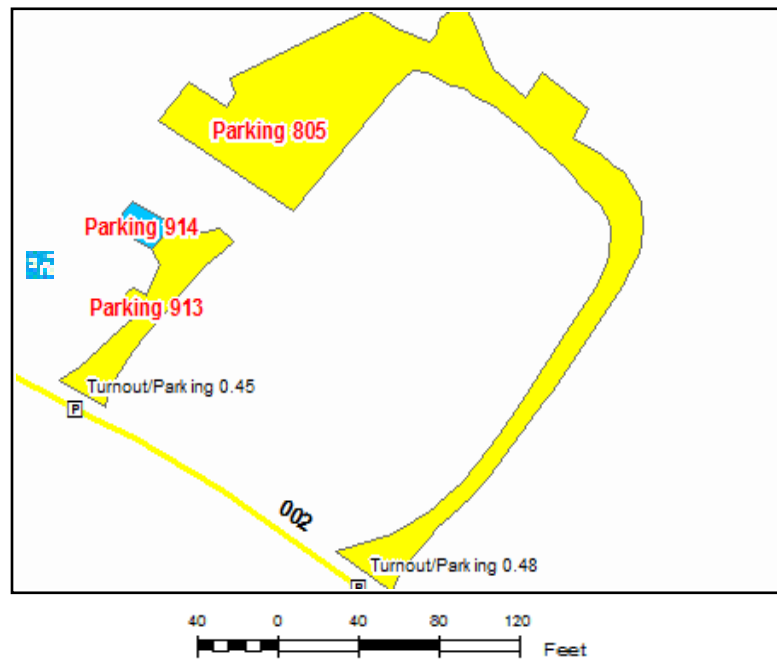
805: Ecological Services Office Employee Parking

Asset Number	Date Visited	Surface Type	Area (Sq Ft)	Condition	Cost to Improve
	01/28/2011	Gravel	14,557	Fair	3,600

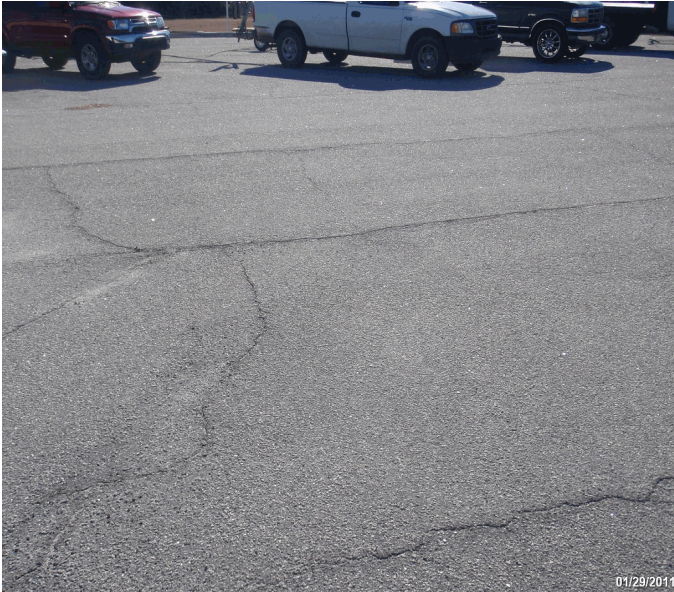
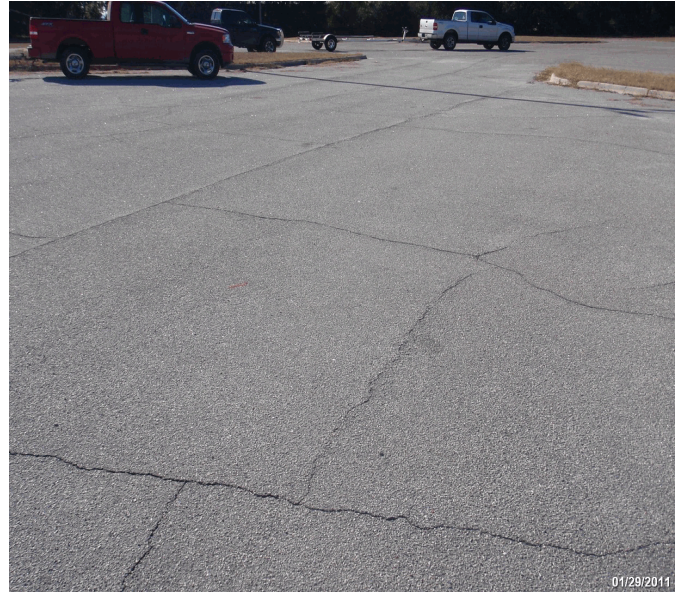
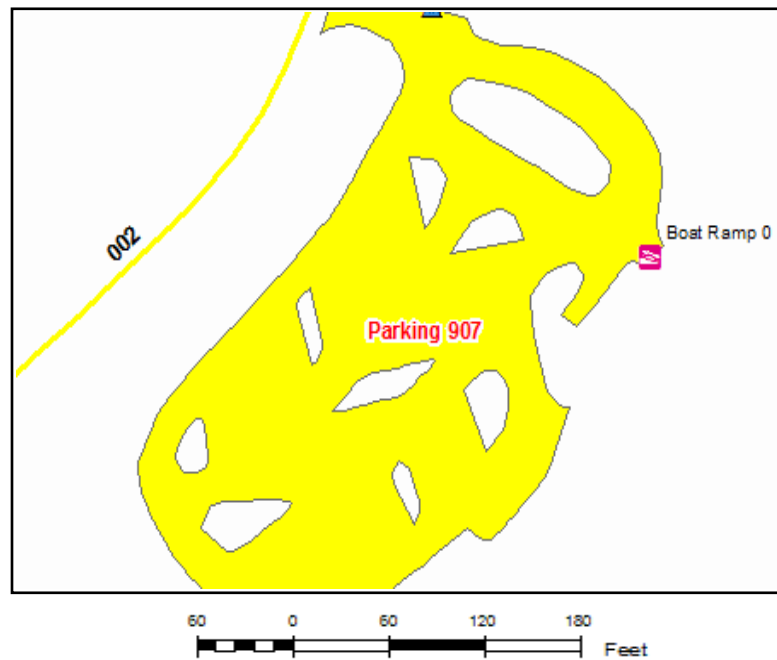
907: Barbour River Landing Parking

Asset Number	Date Visited	Surface Type	Area (Sq Ft)	Condition	Cost to Improve
10015055	01/29/2011	Asphalt	76,980	Fair	61,200

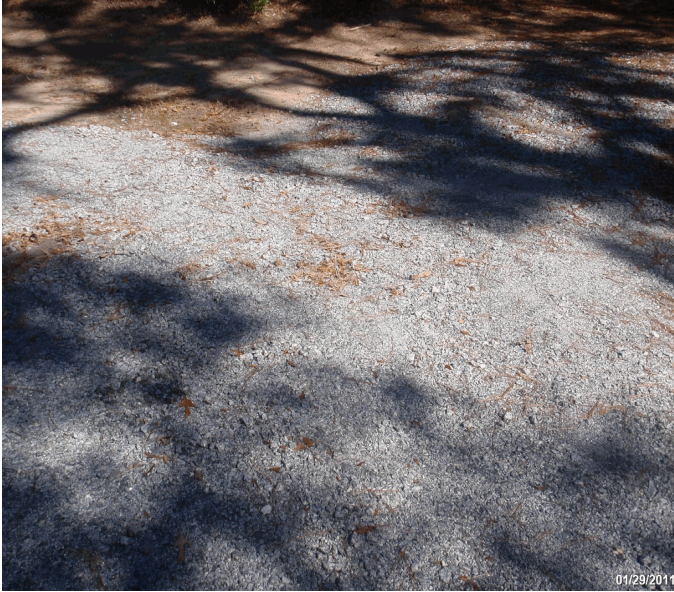
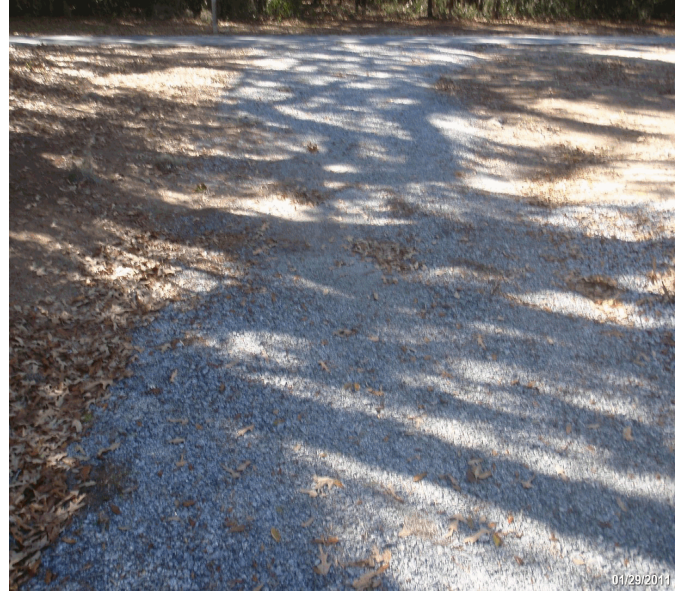
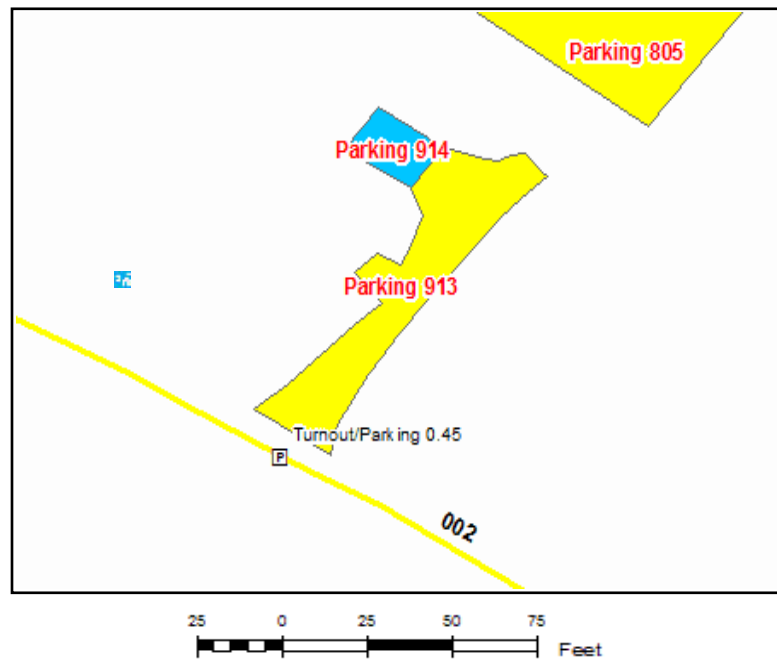
913: Ecological Services Office Public Parking

Asset Number	Date Visited	Surface Type	Area (Sq Ft)	Condition	Cost to Improve
	01/28/2011	Gravel	2,331	Fair	600

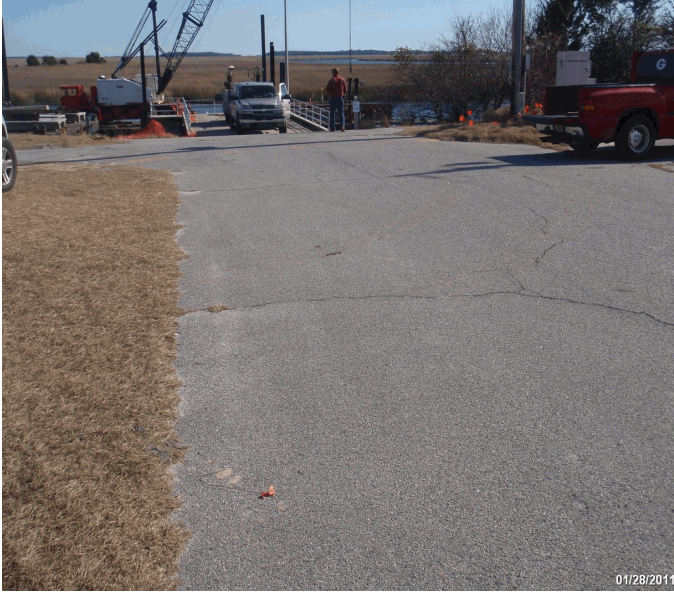
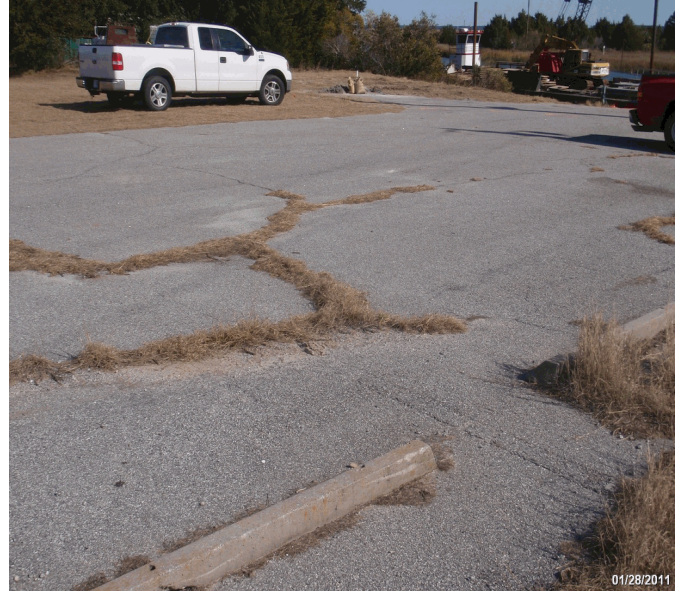
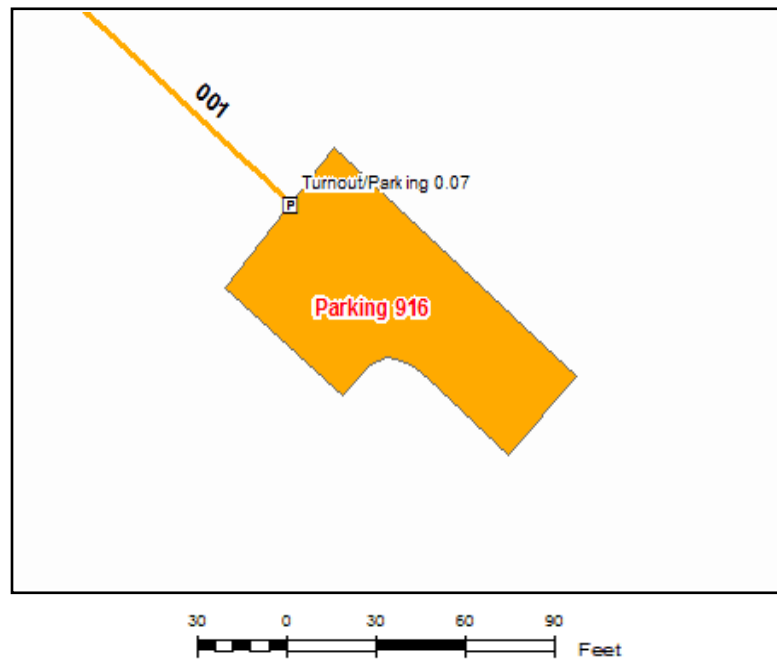
916: Crabber's Dock Parking

Asset Number	Date Visited	Surface Type	Area (Sq Ft)	Condition	Cost to Improve
	01/28/2011	Asphalt	6,475	Poor	28,800
